Founded in 1965, the New Mexico Junior College (NMJC) just north of the City of Hobbs in southeastern New Mexico. The campus serves approximately 2,800 students and is the major higher education institution in Lea County in the southeast quadrant of the State. NMJC offers courses of study for a range of career tracks, from automotive technology to cosmetology to entertainment tech to nursing, as well as general studies that lead to an Associate of Arts or Associate of Science degree. The 2019 NMJC Campus Master Plan updates the 2005 NMJC Facilities Master Plan. It articulates a new vision for the campus, prioritizing maintenance and upgrades to existing facilities, enhancing safety and security, and strengthening the campus identity.

# 7. EXISTING CAMPUS CONDITIONS ASSESSMENT

As part of this Master Plan update, a Facilities Assessment was conducted to analyze the state of each facility. The existing total square footage covers over 480,000 square feet. The assessment found that most of the facilities are in good shape with minor repairs and maintenance required including but not limited to roof repairs and exterior/interior cosmetic repairs. In addition, due to the age of most fa

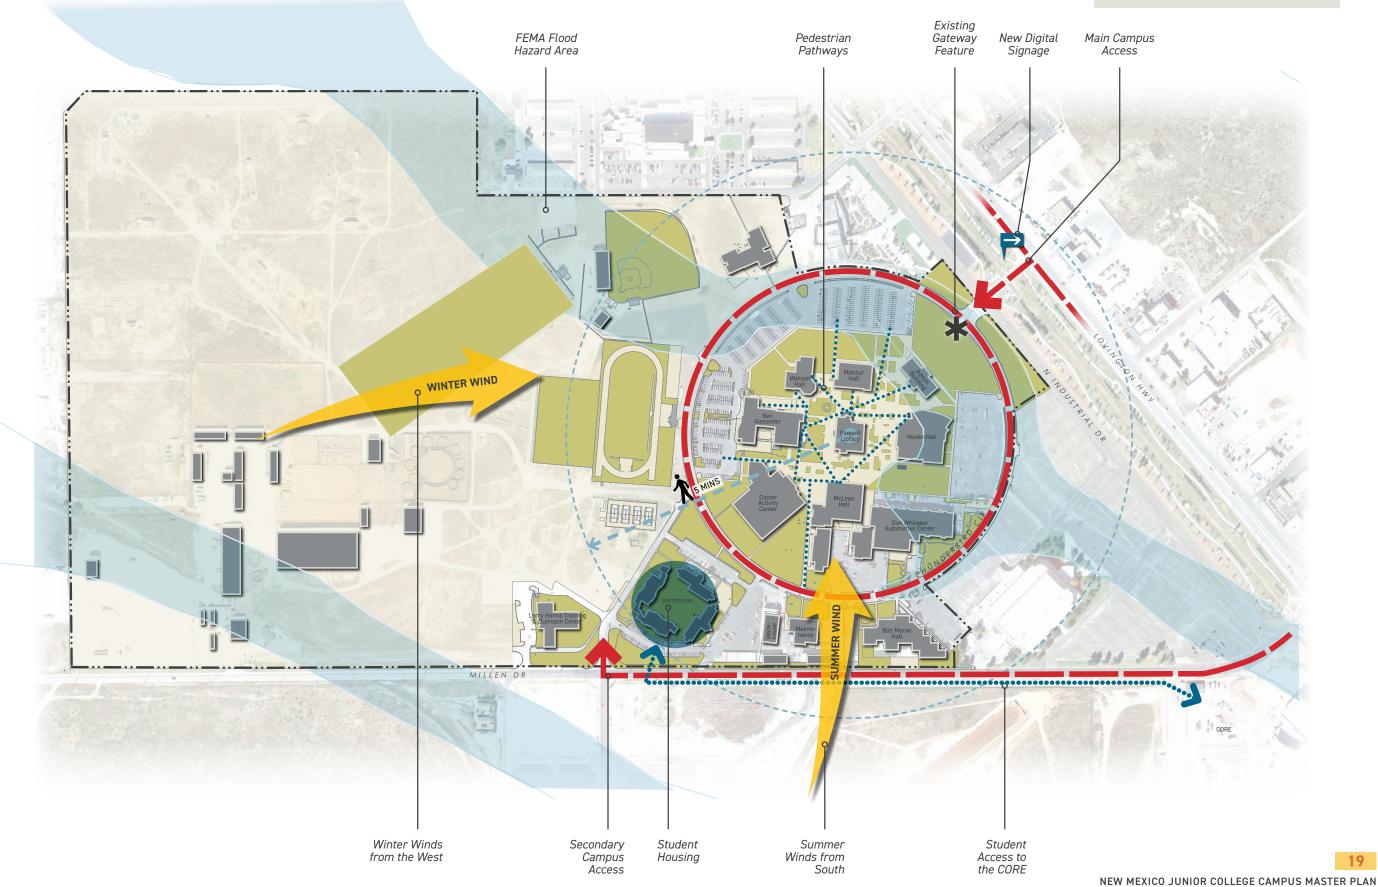
# **EXHIBIT 6. Site Assessment**

According to the FEMA National Flood Hazard Layer, parts of the campus are located in the floodplain. Although Hobbs averages 16 inches of annual precipitation, major floods have occurred in Hobbs on several occasions that have caused significant damage. There is anecdotal evidence that the campus has flooded significantly and boats were used to maneuver the campus floating on the loop road. Storm events generally occur between May and October. Most of the flooding occurs as sheet flow with a depth of one to three inches. Since soil depths are very shallow, the propensity for flash flood events during the monsoon season in the summer are increased.

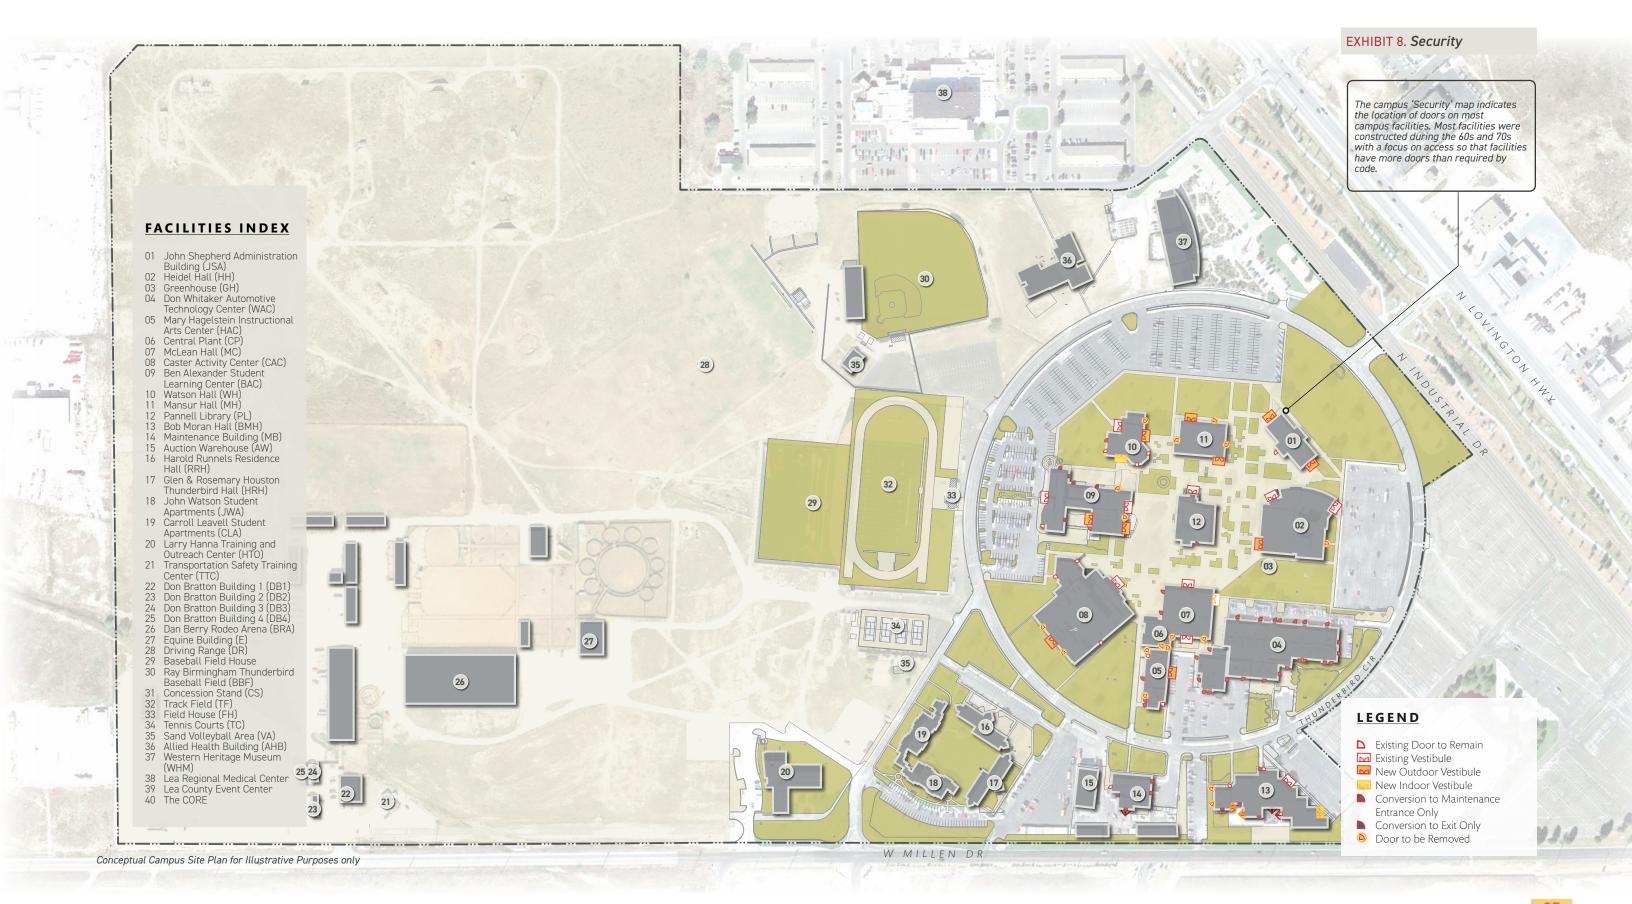
Throughout the campus, there is a lack of signage, wayfinding measures, branding and pathway delineation which creates ambiguous spaces that are confusing to use and are likely to invite unwanted behavior. Currently there is no comprehensive signage system with a general lack of pedestrian-level signage inside the circle and a lack of building-applied signage. Pathways are largely not delineated. For example, the pedestrian areas between facilities within the circle have large expanses of lawn and pavement broken up by seemingly random landscape pieces. These areas are in need of more structured delineation to better orient users. This, accompanied by a comprehensive signage system, would contribute to better wayfinding and territorial reinforcement that enhances security.

The campus facilities assessment revealed that many of the pedestrian hardscape walkways are in need of repairs and maintenance. The network of tunnels that are below some walkways also need repairs that necessitate the reconstruction of the sidewalks above.

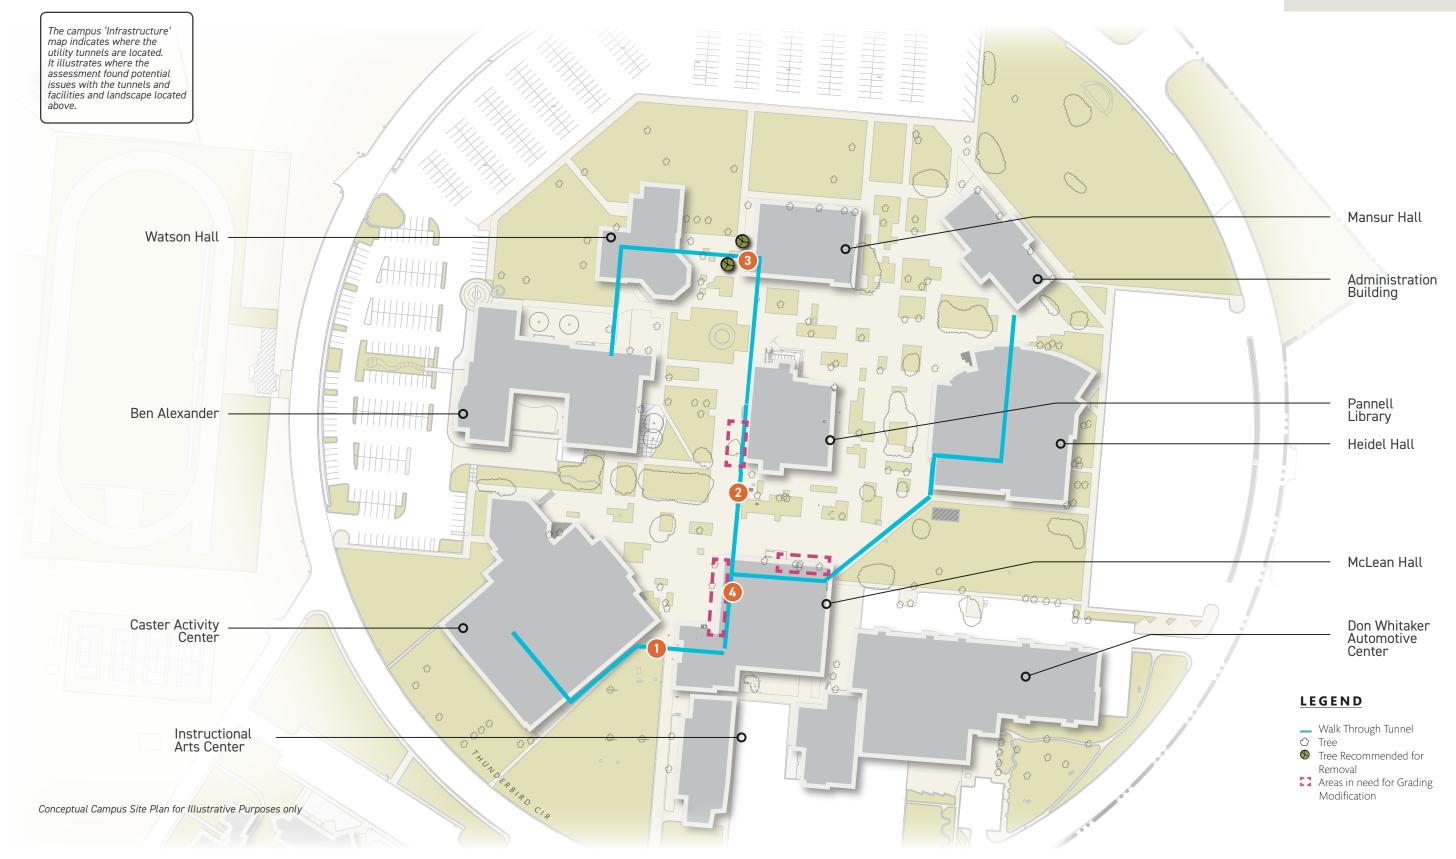
Some sections also show water damage in locations where tunnels are located under buildings. In these instances, one of the exterior tunnel walls is the foundation of the building wall above. Some of these sections that pass underneath McLean Hall and Pannell Library require grading modifications to correct the pooling and seepage under the foundation of the building and into the tunnels.

Water seeping into tunnel causes rust and panel separation from ceiling

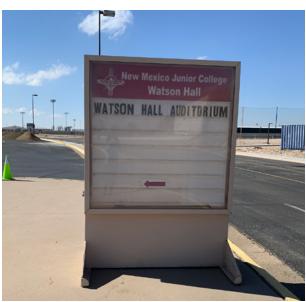
Signage along the loop road is faded and does not follow a unified design theme.

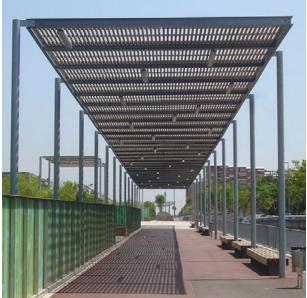
### PRECEDENT IMAGES 7. Shade Structures

Shade elements that shade key outdoor areas and pedestrian pathways
